# DIXIE HIGHWAY TROLLEY LINE

## TREE REMOVAL & REPLACEMENT PLAN

Ft. Mitchell, KY | May 2018

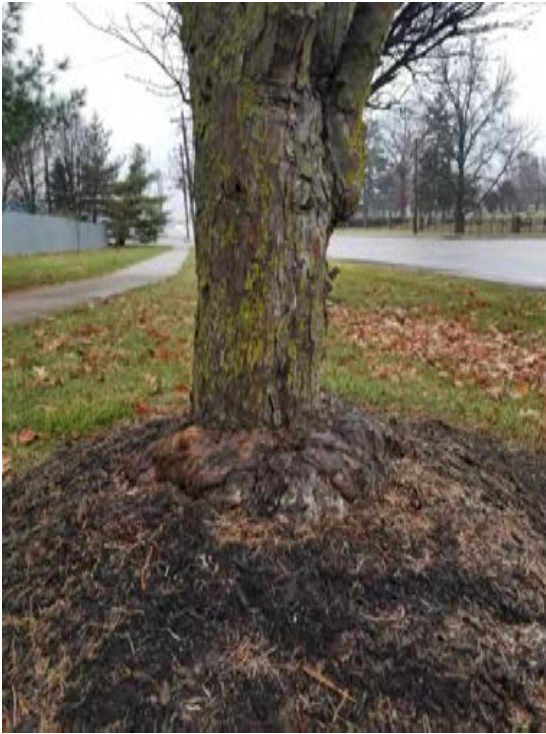
Significant mechanical damage around root collar, including decay and trunk splitting further above ground.

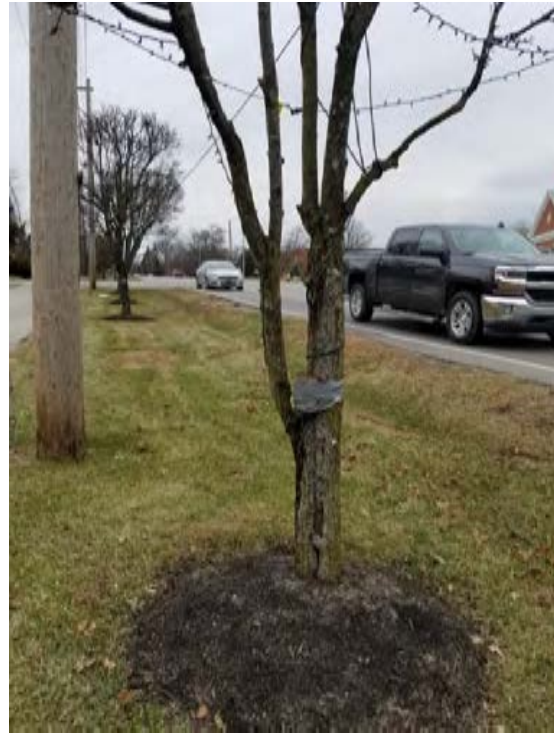
Mechanical damage at base and excessive mulching (no root collar visible). Duct tape used to attach holiday decorations.

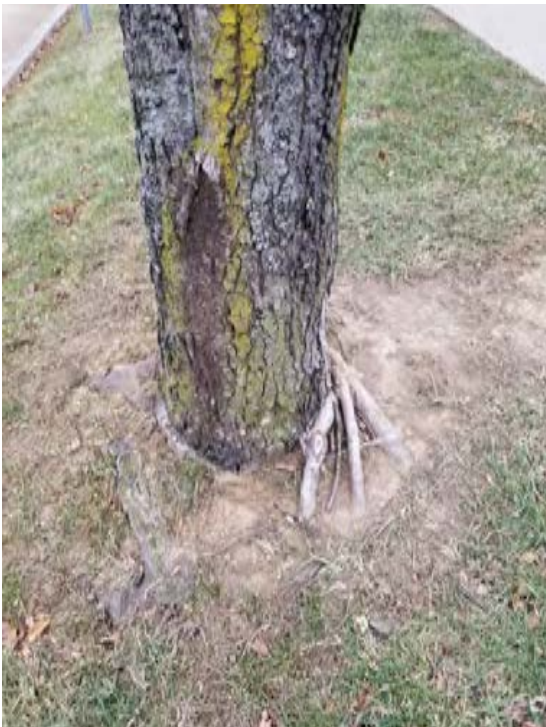
In compacted soil with girdling roots and no visible root collar.

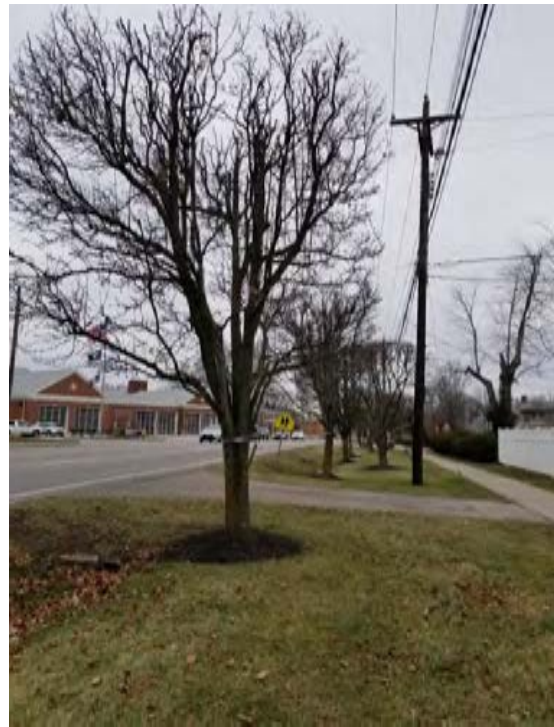
- All the pear trees have inherently poor structure. The trees have been repeatedly pruned for aerial line clearance and several trees have trunk and branch defects. Therefore, it is likely there will be frequent limb and trunk failures during storms.

Pear trees have poor structure with multiple codominant stems and are subject to severe utility pruning.
