Background

This traffic study was initiated by the City of Fort Mitchell in response to concerns from citizens about traffic operations of Beechwood School and Beechwood Road. This traffic study included a general overview of traffic conditions on Beechwood Road from Dixie Highway to Deauville Court. Included in the study were observation of Beechwood School's arrivals and dismissals and the internal vehicular circulation at the school.

CDS ASSOCIATES, INC.
Knowledge • Expertise • Innovation

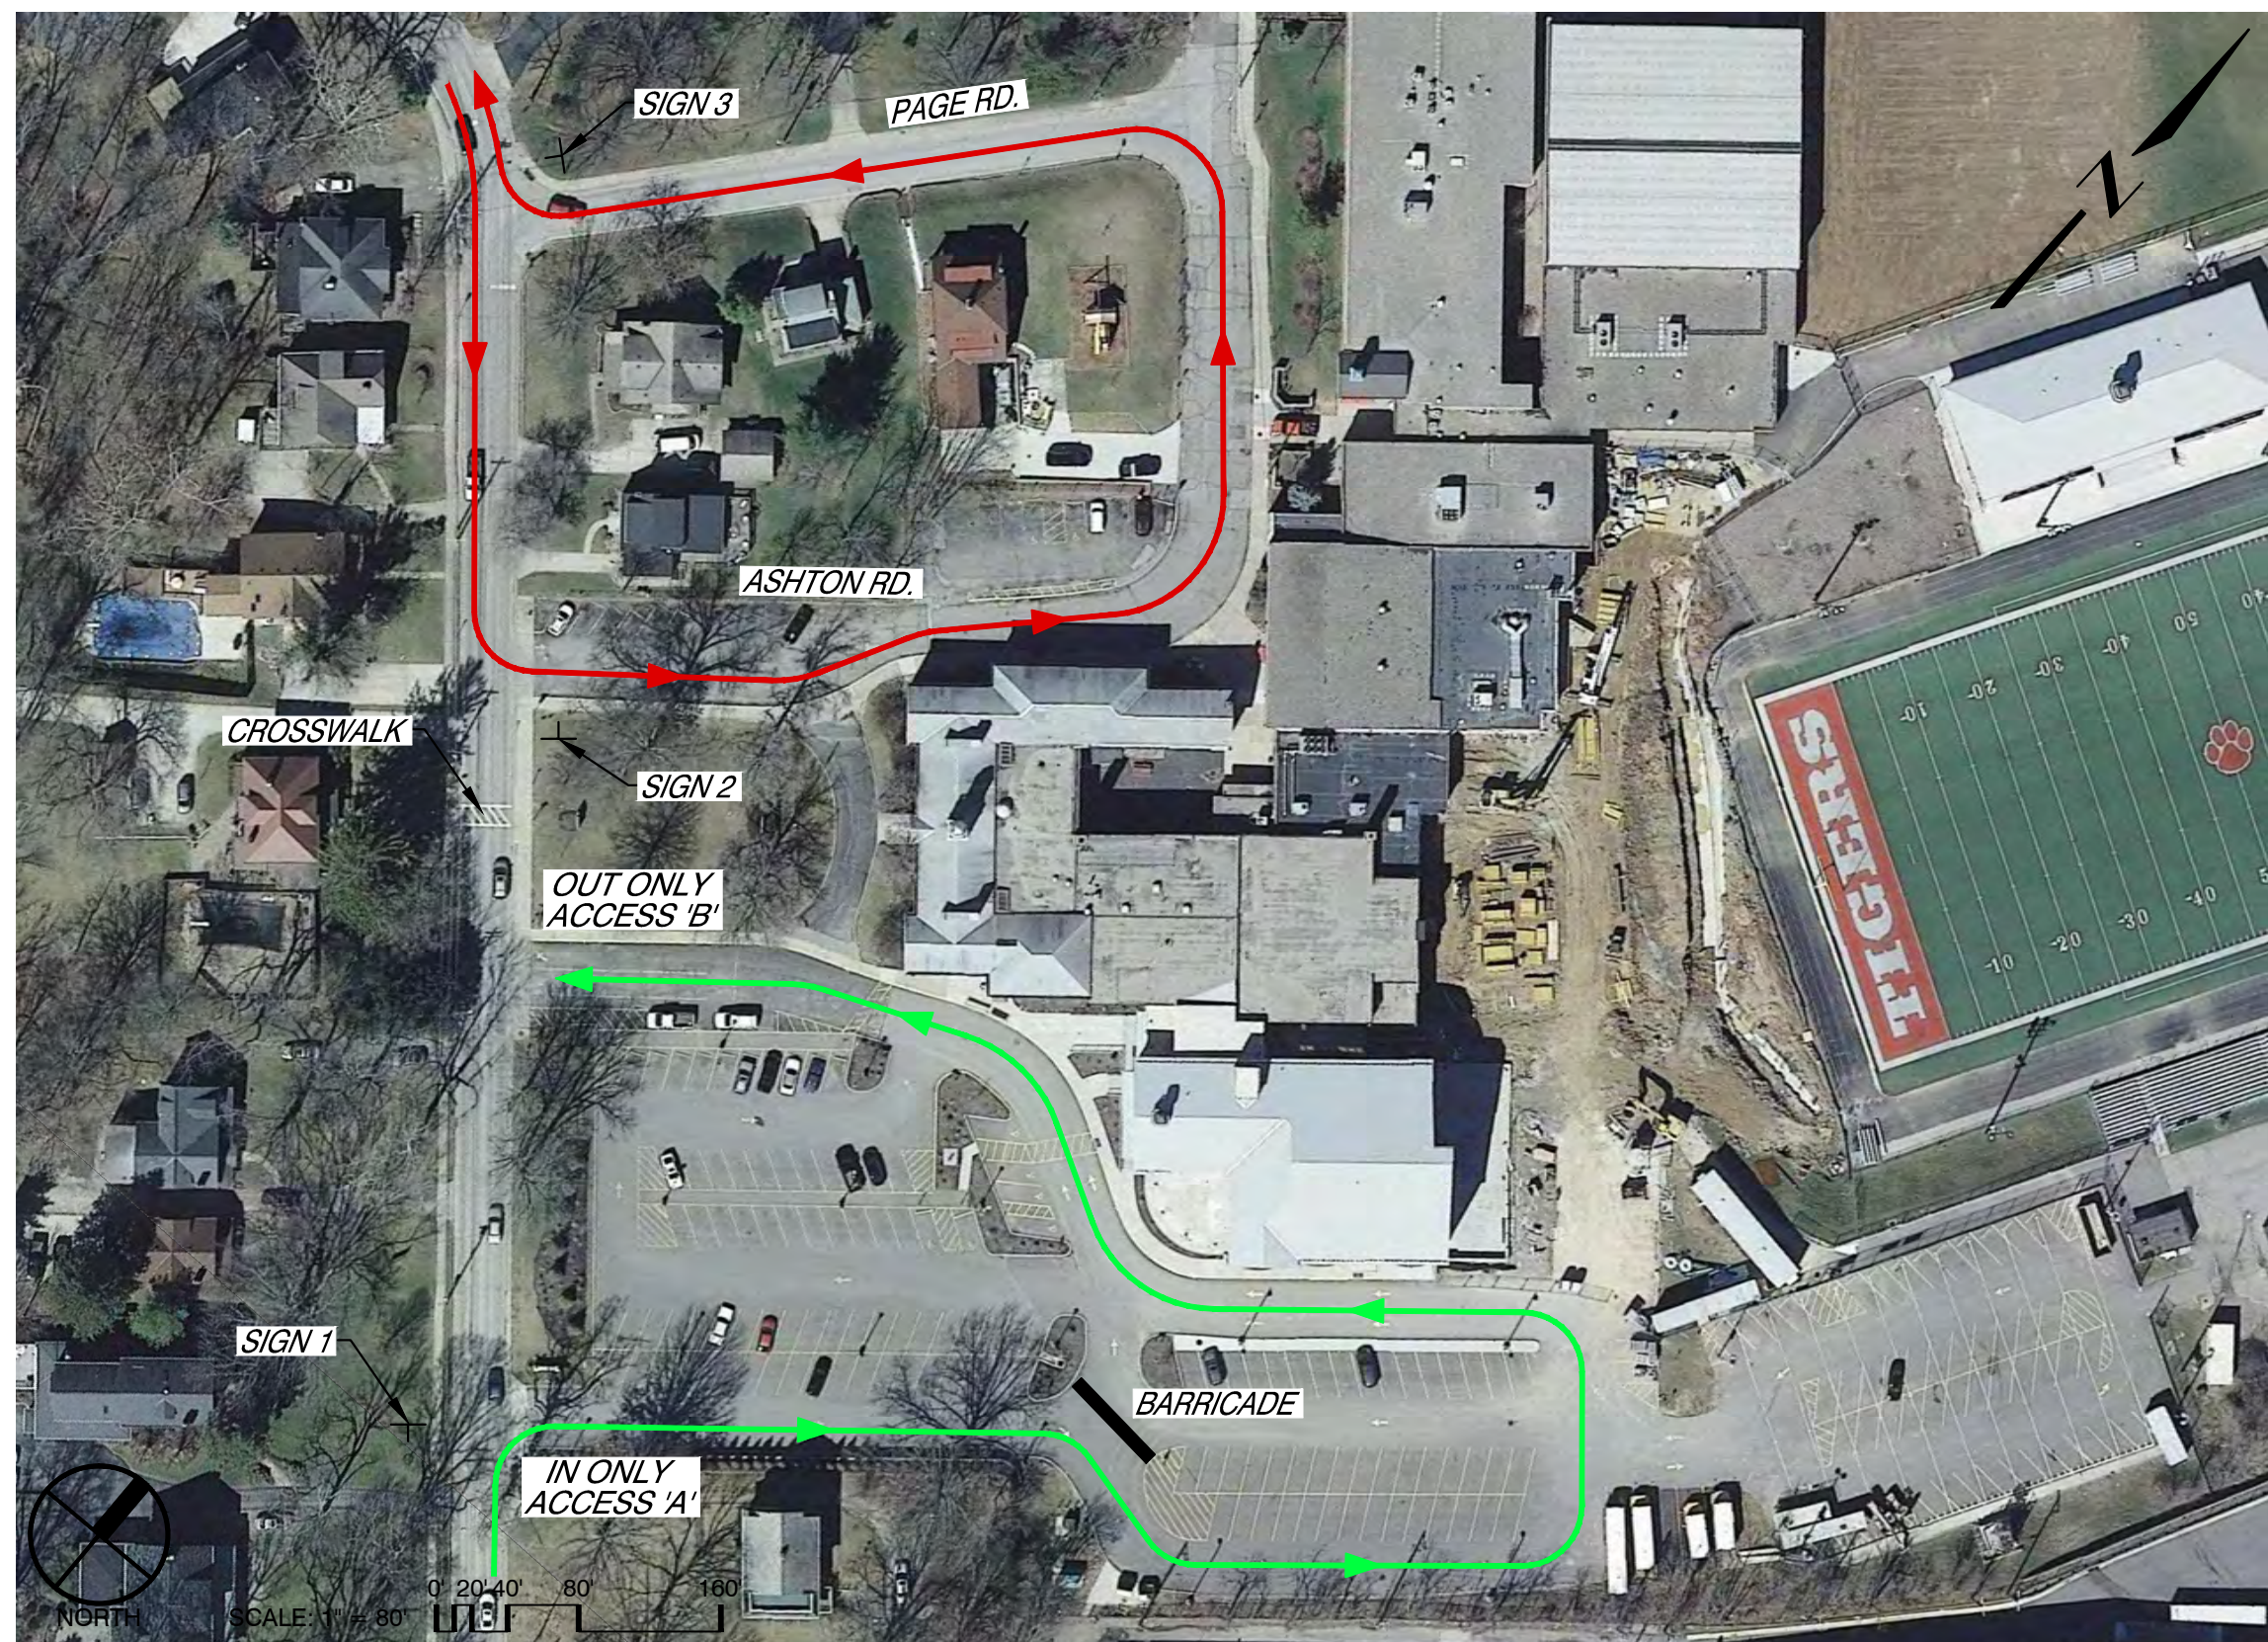
BEECHWOOD HIGH SCHOOL - FIGURE 1

There are four access locations to the school, see Figure 1. At the eastern limits of the school property there is an 'In only' access referenced in this report as Access A. All westbound school traffic is designed to enter at this access only. Traffic enters and circles the site, green arrows, drops off students at the curb at the perimeter of the building and then exits onto Beechwood Road. Westbound traffic is prohibited from turning right into Ashton Road. There is a school staff monitoring/enforcing this prohibition during the arrival and dismissal times.

Eastbound school traffic is not permitted to turn into Access A. There is a regulatory NO LEFT TURN sign with the prohibited times installed on Beechwood road by Access A. This prohibition is routinely violated by eastbound school traffic. During CDS's observation periods, school staff was not stationed at this location.

Eastbound school traffic turns left onto Ashton Road, see red arrows, and exits by turning left onto Page and turning right only onto Beechwood. There are regulatory NO LEFT TURN prohibitions with the specific times of the day posted on Page Road. During the AM arrival school staff is present to ensure traffic does not turn left. During the PM dismissal school staff is not present and the prohibition is not respected as reported by school staff.

There is a midblock crosswalk located between Ashton and the school's exit driveway, see Figure 1. A school crossing guard is present during the arrival and dismissal times, wearing highly visible safety vest and using appropriate signing. Based on observations students and parents approaching the school used the crosswalk and did not jay walk.

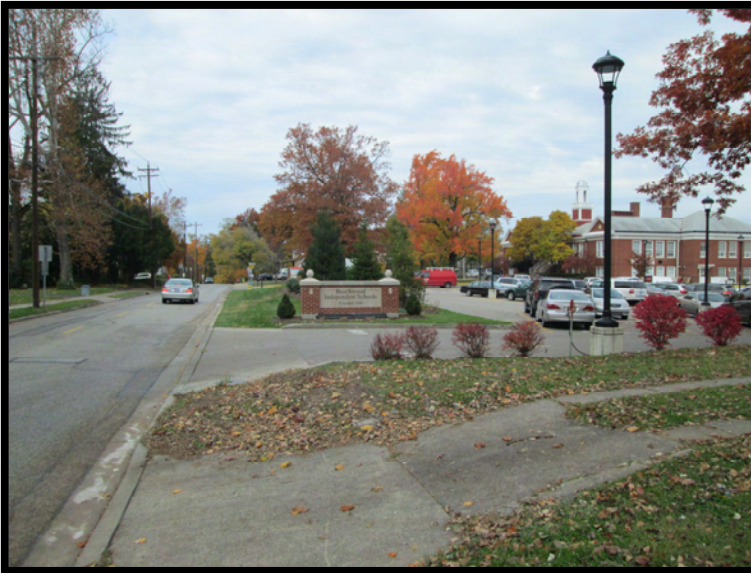
Photo 1, Access A
Viewing westbound at
School Entrance

For school arrivals and dismissals, this is Beechwood's only entrance for westbound oriented traffic. The driveway is two lanes wide and is inbound only, see Photo 2. The designation for one-way in is indicated with small pavement markings which are only visible upon entering.

It would be desirable to install ONE WAY ARROW signs (R6-2) 24" x 30" (vertical rectangle),

two signs mounted back to back on one support post on the east side of the driveway; and two signs mounted back to back on the west side of the driveway. If the school ever experiences traffic attempting to exit this driveway, (R5-1A) WRONG WAY signs could be installed on the back of the sign posts and the ONE WAY ARROWS could be changed to horizontal arrows similar to arrows on Photo 65.

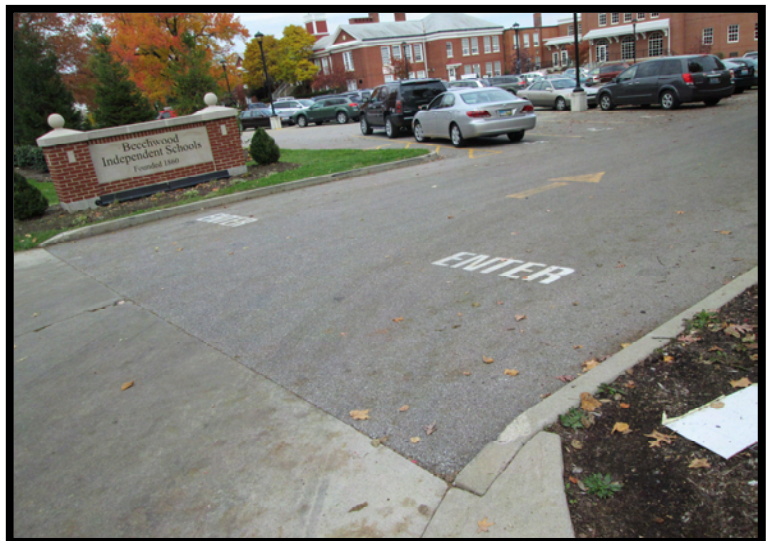
Photo 2, Access A
School Entrance

School entrance. Not recognizable that this is an entrance only until turning maneuver is made.

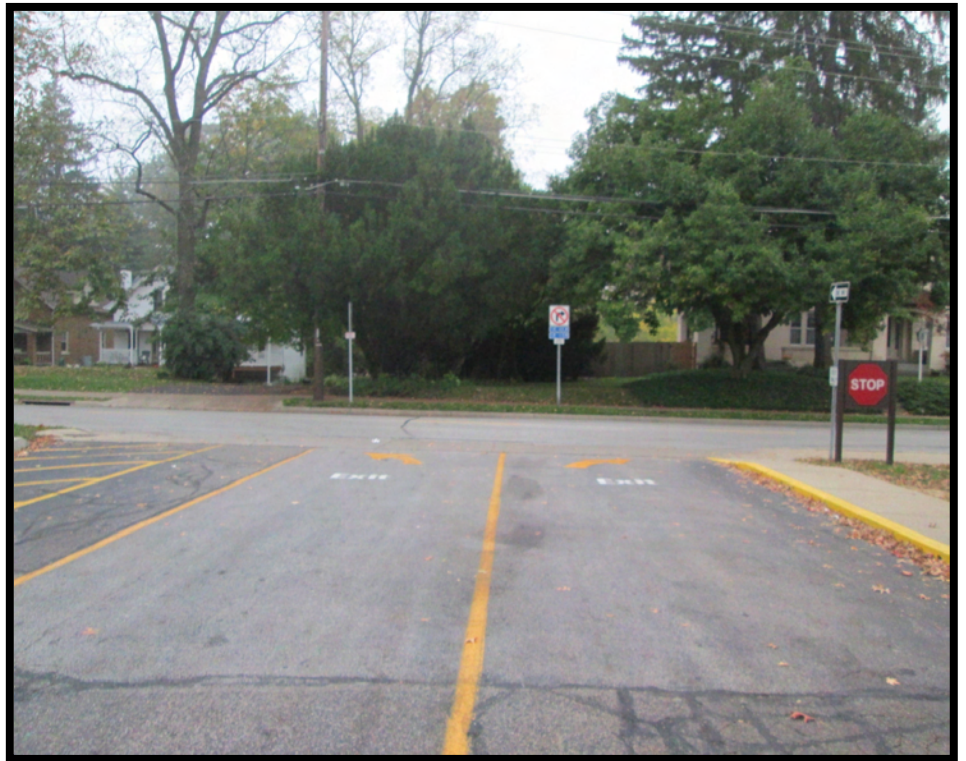
**Photo 3, Access B
Exit Driveway**

Pavement markings are non-standard in color and size. All pavement markings should be white for both channelizing line and arrows, see Photo 4. The size of the arrows should be 6 feet in length.

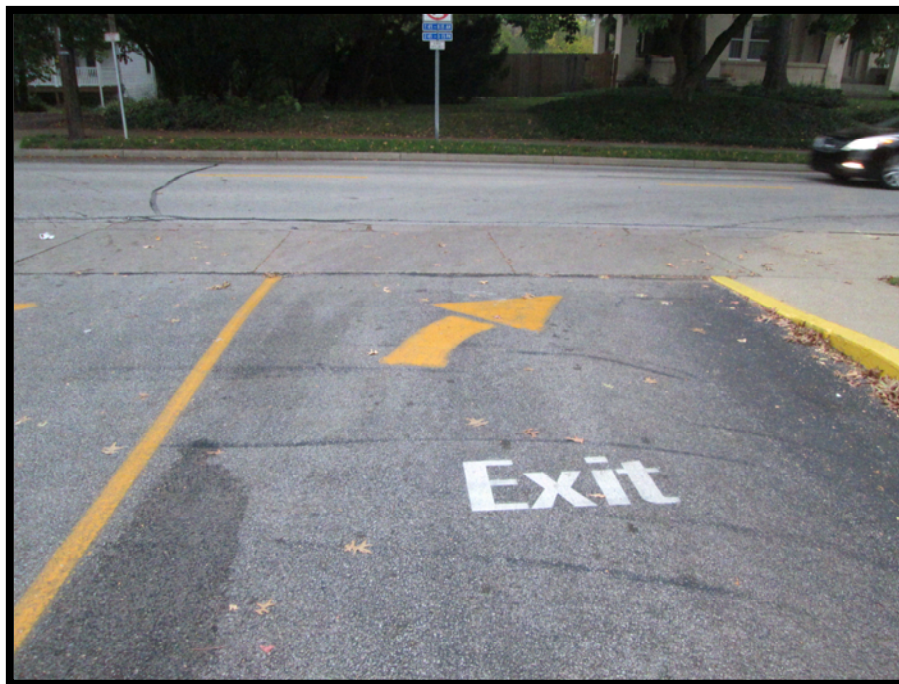
**Photo 4, Access B
Exit Driveway**

Existing arrows are small and wrong color. Exit pavement r necessary if correct size arrows are used.

Also recommend the installation of a 24" stop bar behind the sidewalk to extend across both exit lanes.

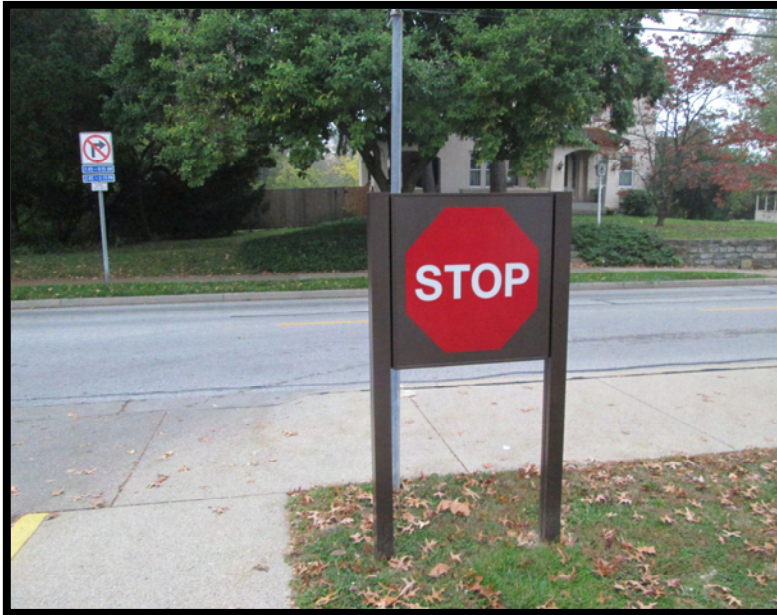
**Photo 5, Access B
Exit Driveway**

STOP sign is non-standard, non-reflectORIZED, mounted too low. A secondary STOP sign assembly identical to the one in the photo is located on the east side of the driveway.

On the back of the STOP sign is a non-standard DO NOT ENTER. See Photo 6 for full description.

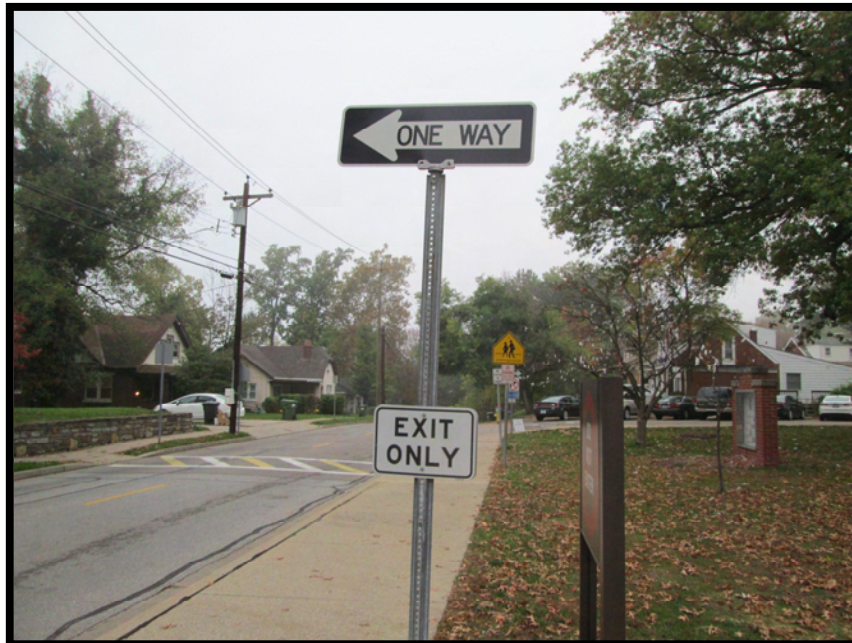
**Photo 6, Access B
Exit Driveway**

ONE WAY directional sign installed in front of the STOP/DO NOT ENTER sign with a small non-standard EXIT ONLY sign.

The ONE WAY sign is used correctly; however, the typical application includes the STOP sign and DO NOT ENTER sign installed back to back below the ONE WAY ARROW. The STOP/DO NOT ENTER signs are mounted at a height of 7' measured from the bottom of the STOP sign. This signing application is highly visible in both day/night conditions for traffic exiting the school and traffic traveling on Beechwood Road. Due to the very wide pavement of this access, we would recommend one set, one each side of the driveway.

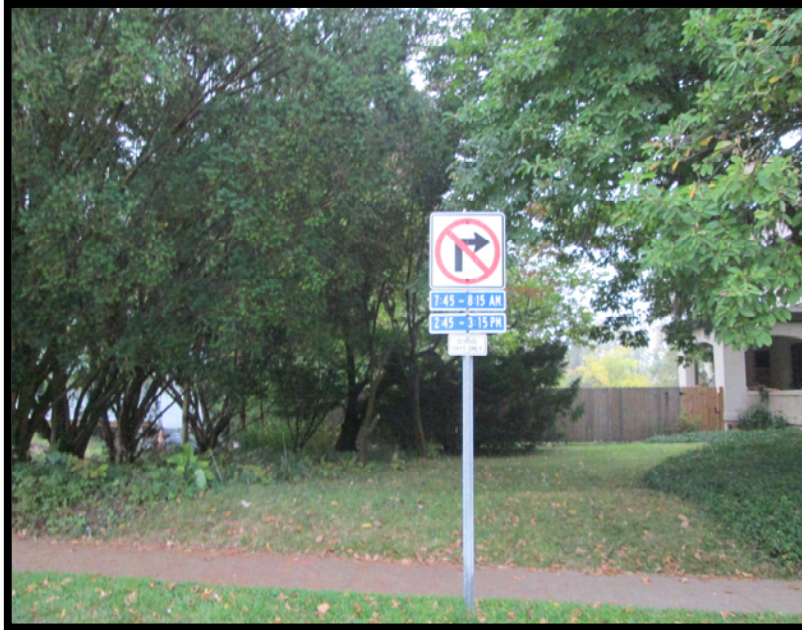
**Photo 7, Access B
Across from Exit Driveway**

Turn prohibition across from exit access which applies to opening and closing hours; however, this prohibition was from a previous time during construction and is no longer applicable. Sign should be removed.

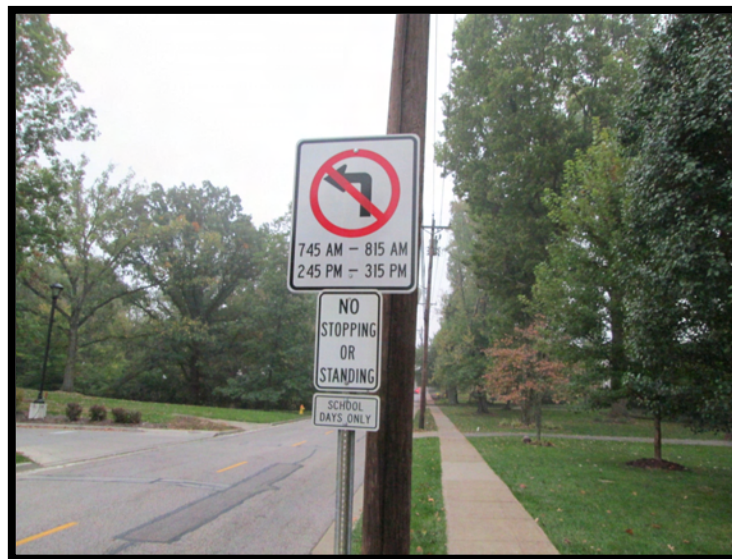
**Photo 8
Viewing Eastbound**

The LEFT TURN PROHIBITION is to prohibit left turns into the inbound school driveway during school arrival and dismissal times.

- The sign is located too far from the driveway;
- From AM and PM observations and report from school crossing guard, this sign is routinely violated;
- Due to motorists stopping to turn left into the school, traffic queues back into the crosswalk.
- This prohibition should be enforced with either school staff and/or the placement of traffic cones on the centerline during the opening and closing times only. Since this movement is routinely violated, once the enforcement begins, some additional congestion can be anticipated to occur on a temporary basis as eastbound traffic adapts to the prohibition. This could include motorists driving past the school and turning around in residential driveway.

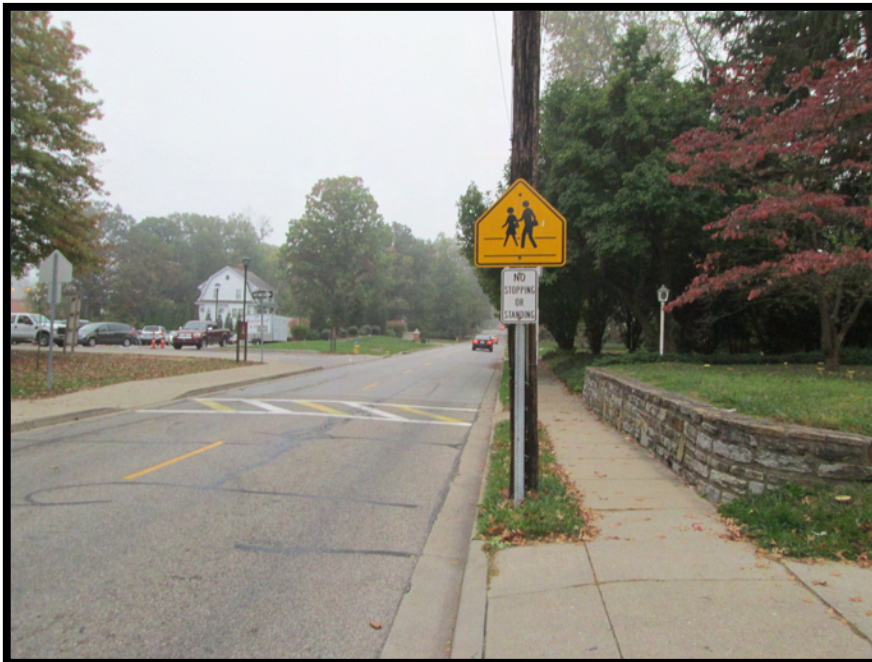
Photo 10
Viewing Eastbound
Crosswalk

Sign located too far from crosswalk. Sign should be removed and a new fluorescent yellow-green sign installed at the crosswalk as described in Photo 9 narrative.

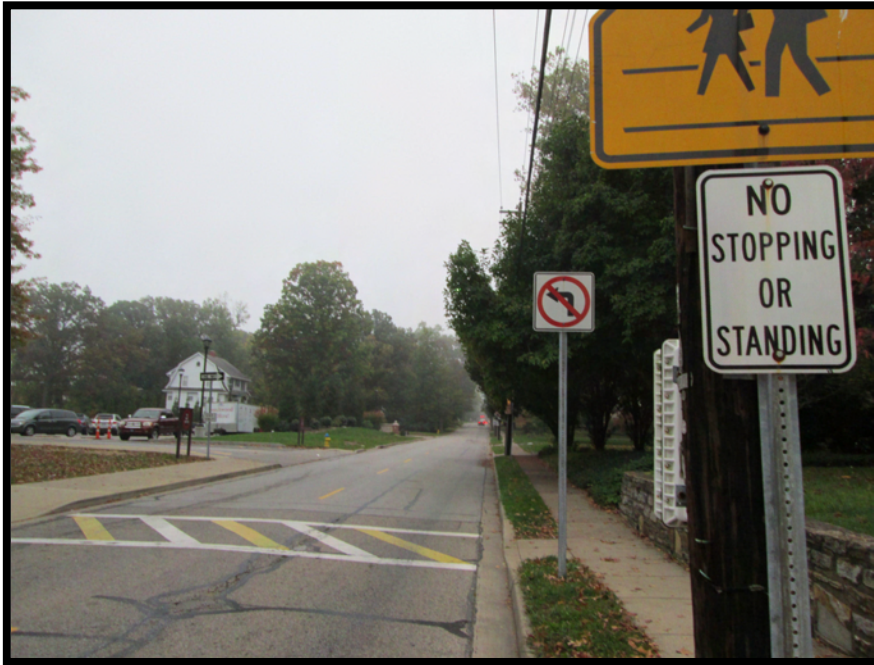
Photo 11
Viewing Eastbound

The existing NO LEFT TURN sign located at the crosswalk should be removed and replaced with the SCHOOL CROSSING sign referenced in Photo 10.

Subsequent to the installation of the NO LEFT TURN sign, the school's driveway traffic flow was modified and this sign no longer applies to the adjacent driveway, which is now an exit only.

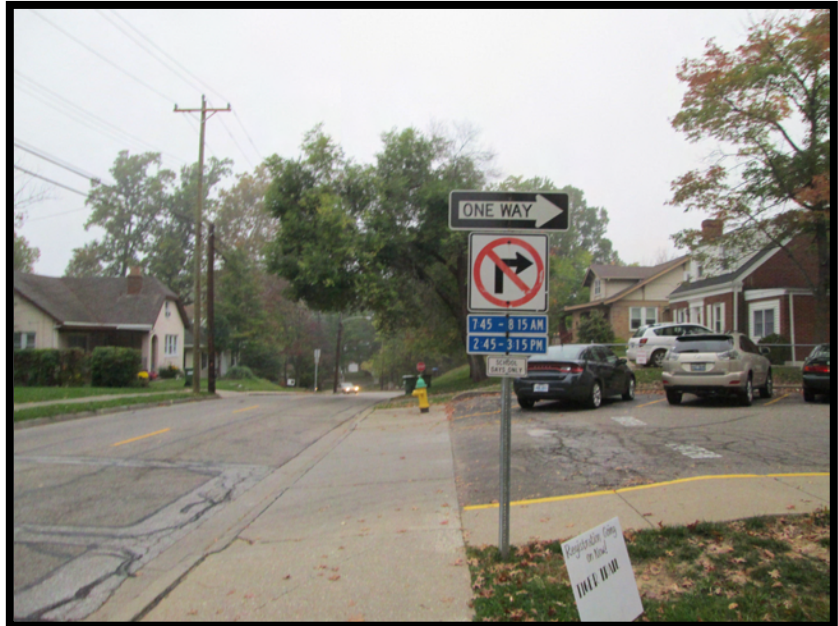
Photo 13
Viewing Westbound on
Beechwood at Page

This sign assembly is somewhat confusing as it indicates the driveway is one-way inbound and also right turns are not permitted during school days opening and closing times.

The prohibition times are indicated on blue plaques and the legend SCHOOL DAYS is indicated on a small non-standard plaque.

School staff currently enforce the no right turn prohibition during school arrival and dismissal times.

To reduce confusion and increase readability, CDS recommends removing the ONE WAY ARROW. In addition, replace the prohibition times plaque with a larger regulatory plaque (S4-1P) 24" x 10" black letters on white background and increase the size of the SCHOOL DAYS plaque using a modified (S\$-4P) plaque, 24" x 10".

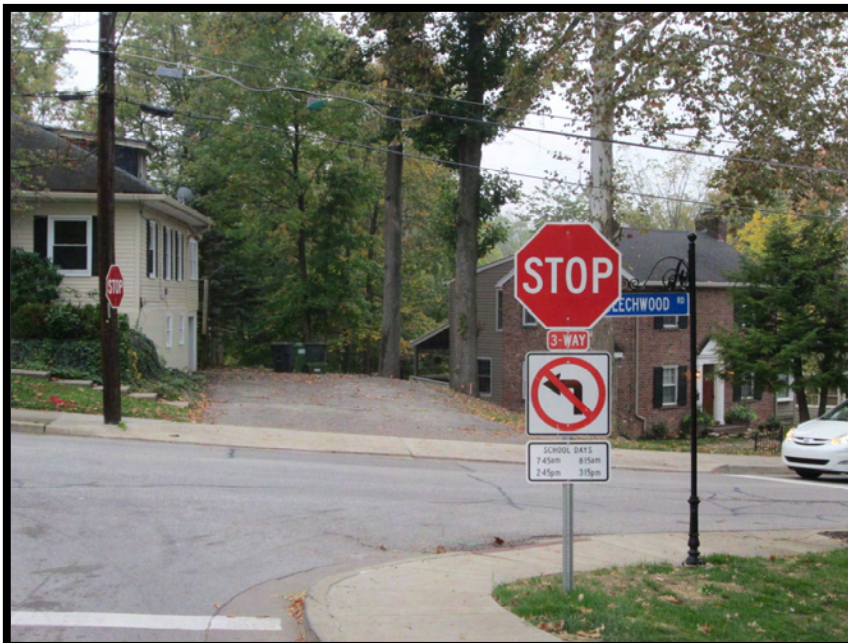
Photo 14
Viewing Southbound on Ashton
at Beechwood

During morning arrival and afternoon dismissal, all traffic exiting Page Road must turn right. In the morning, only a school staff member directs traffic at this location. In the PM, staff is not present and violations occur.

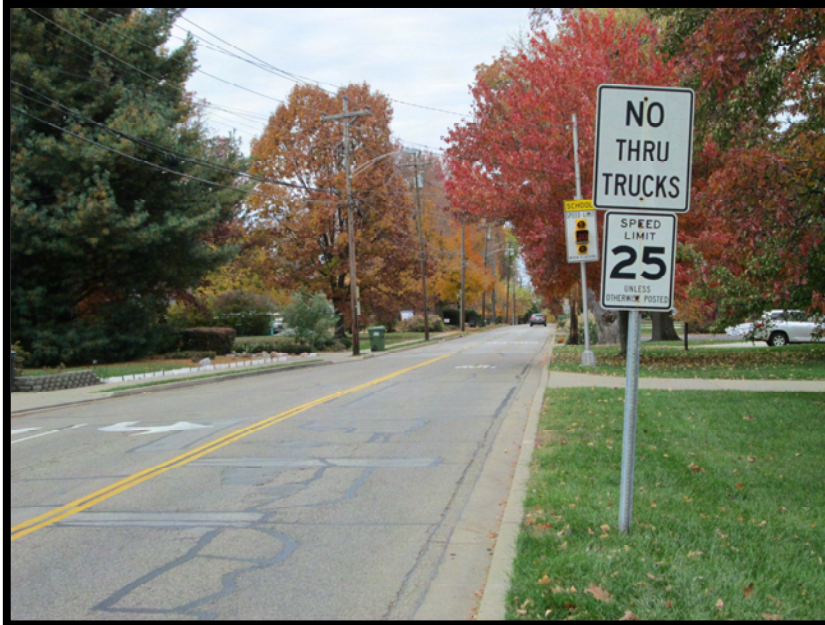
Photo 15
Viewing Westbound, just West of Dixie

KRS 189.336 (3) states, "...Flasher lights shall be placed one-eighth (1/8) of a mile on each side of the principle school building where practical..."

The existing location is approximately 1,250 feet from the school building almost twice the distance.

CDS recommends relocating the speed limit assembly to the appropriate location and install the SCHOOL pavement marking adjacent to the flasher.

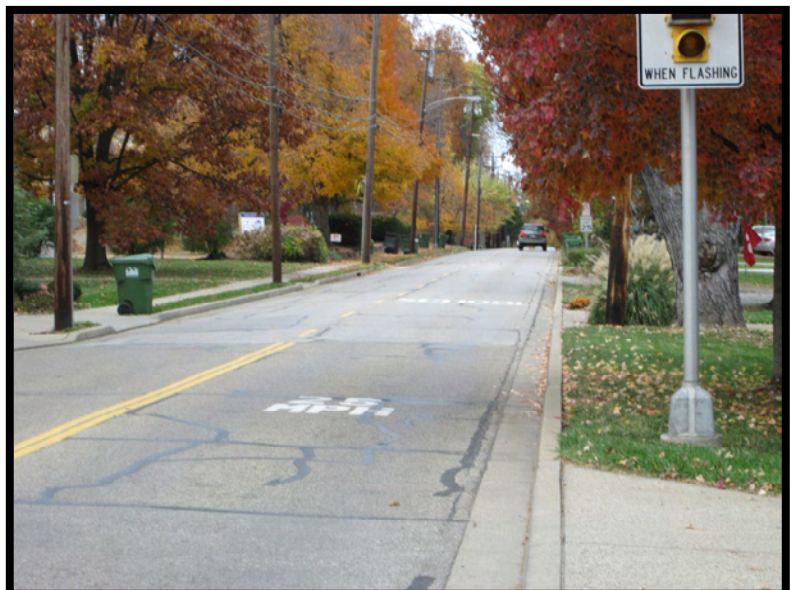
Photo 16
Viewing Westbound Adjacent to School Flasher

Small 25 MPH pavement marking located next to the school flasher.

Recommend removing the non-standard 25 MPH pavement marking.

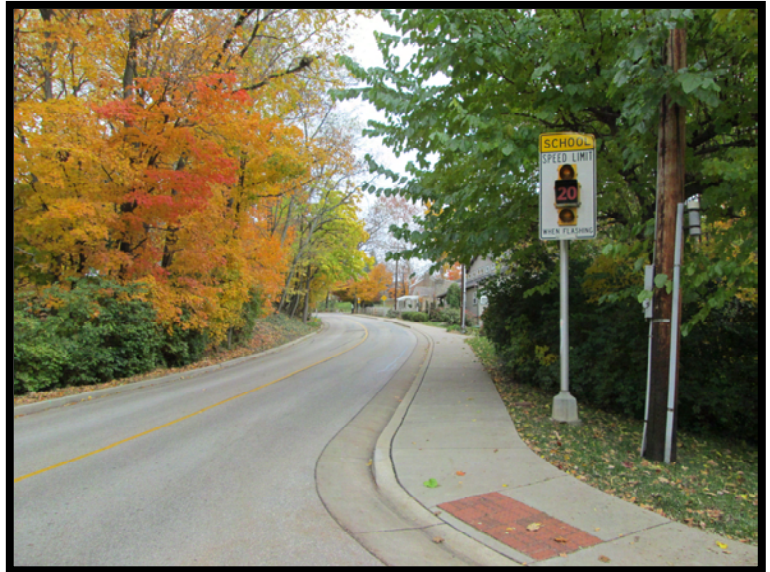
Photo 17
Viewing Eastbound from
Deauville Court

School speed limit assembly
flasher. Recommend installing
standard SCHOOL pavement
marking adjacent to flasher.

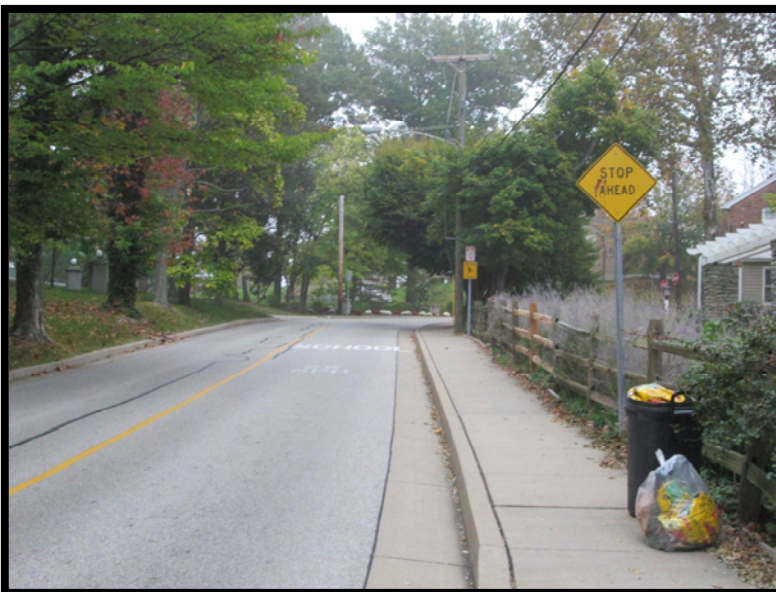
Photo 18
Viewing Eastbound East of
Photo 17

STOP AHEAD warning sign should
be replaced with a (W3-1) STOP
AHEAD, 36" x 36".

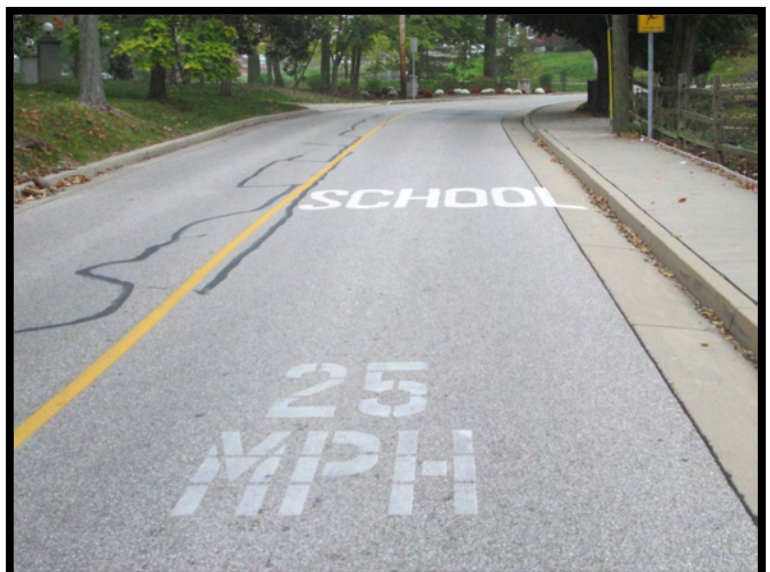
Photo 19
Viewing Eastbound from
Deauville

Mixed message, non standard 25
MPH pavement marking next to a
SCHOOL pavement marking.

Recommend removing the 25 MPH
pavement marking. Install a
SCHOOL pavement marking
adjacent to the school flasher.

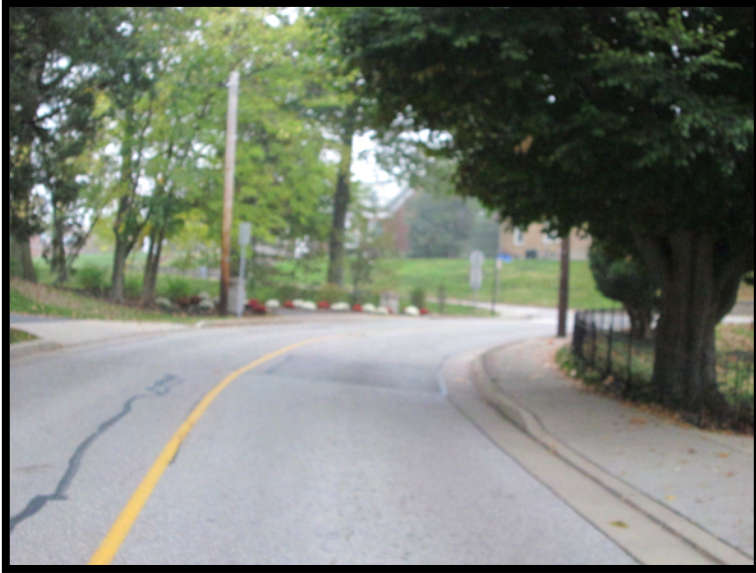
Photo 20
Eastbound on Approach to Page Road

STOP signs not visible due to combination of vegetation and road geometry.

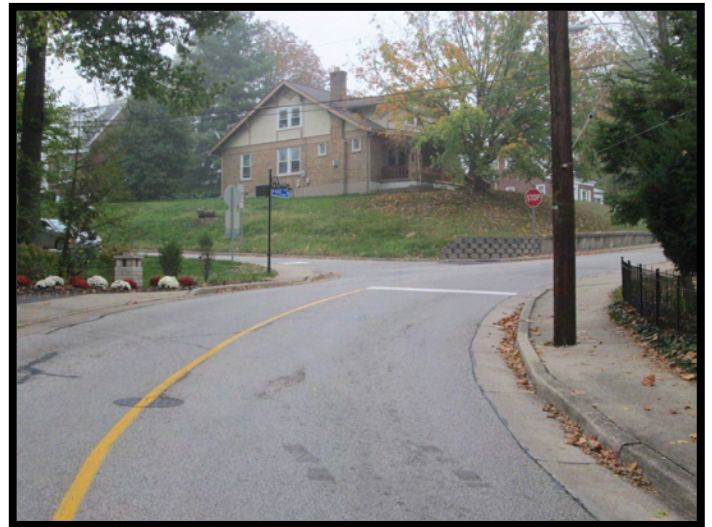
Photo 21
Viewing Eastbound West of Ashton

STOP sign on the northeast corner of intersection just visible:

- Installing a STOP sign on the street name sign support (located on the northwest corner) significantly increases the distance the STOP sign can be seen in advance of the intersection.

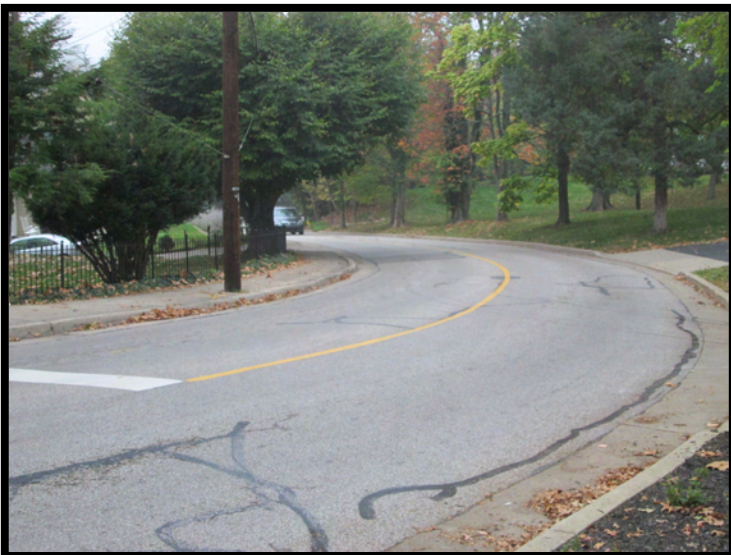
Photo 22
Viewing Westbound from Page

This photo taken at the street name sign support on the northwest corner of Page at Beechwood. Referenced and seen in Photo 21 above. This illustrates the increased sight distance for the stop if the STOP sign is located on the street name support.

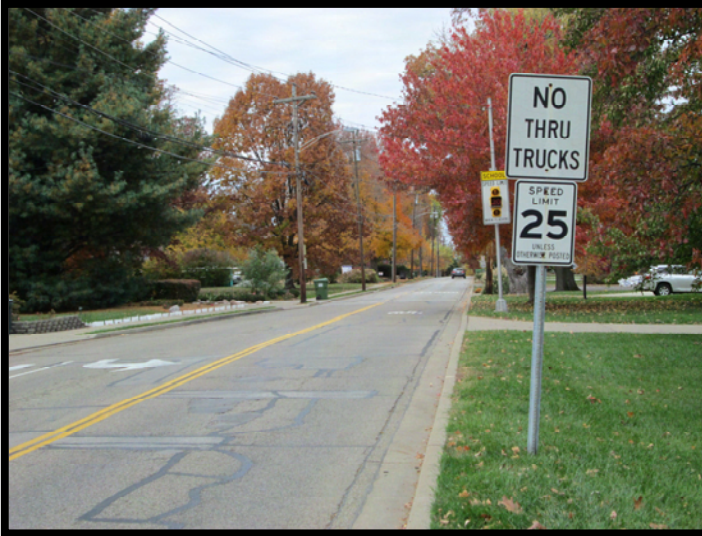
Photo 23
Speed Limit Sign

The sizes of the speed limit signs on Beechwood are 18" x 24". This size is considered 'Minimum' as described in the *Manual of Uniform Traffic Control Devices*. Minimum size signs are acceptable for low volume roads; however, Beechwood Road is not a low volume Road. Given the nature of the traffic on this road, CDS recommends that 'Conventional Road' size signs should be used for all signs on Beechwood. Conventional size speed limit signs are 24" x 30". Recommend installing a 24" x 30 speed limit sign approximately 200 feet west of Dixie for westbound traffic. Across from the

relocated school flashed install a 25 MPH speed limit, and END SCHOOL ZONE.

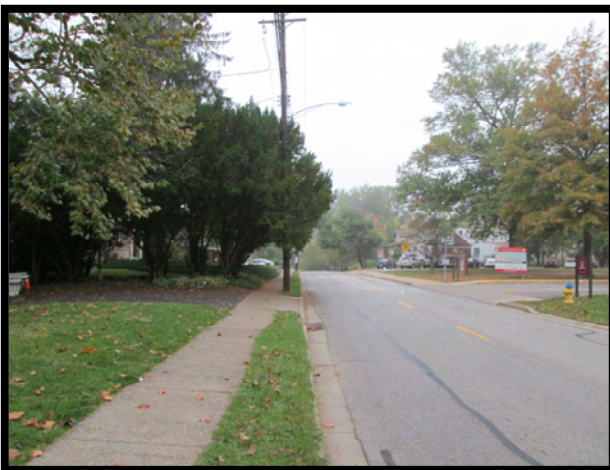
Photo 24, Viewing West Across from School Entrance

There are many locations in the study area where plantings and tree limbs over hang the road which can impact sight distance and reduce the effect of street lighting. All places are not pictured but the photos below illustrate some examples:
